2 A New Year's Day Icebreaker: Icequakes on Lakes in Alberta, Canada

17 **Accepted in the Canadian Journal of Earth Sciences**

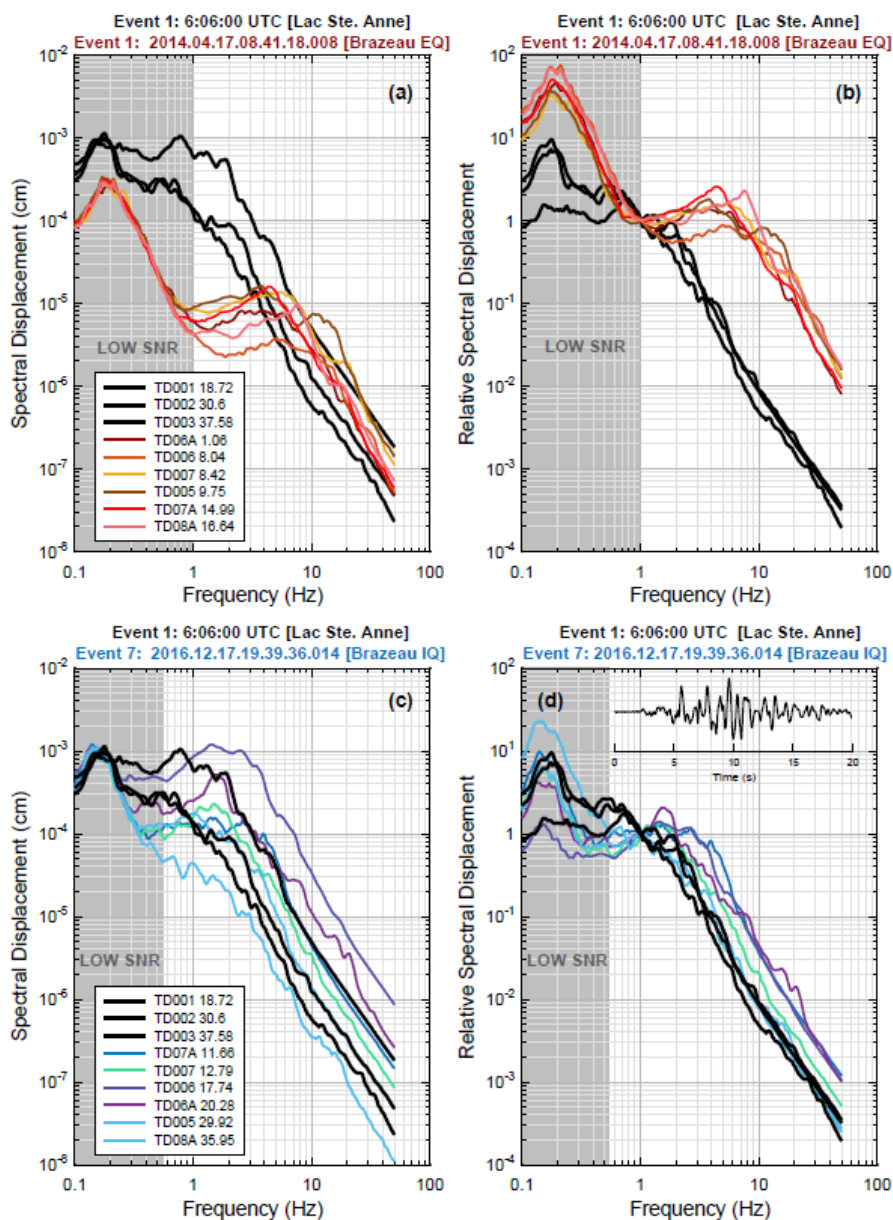
753 **Figure 2. Comparison of seismic event spectra.** (a & c) Unscaled and (b & d) scaled response
 754 spectra for the Lac Ste. Anne event (geometric mean of horizontal components) versus the
 755 natural Brazeau-area earthquake M_L 0.7 (Event 1, a & b) and a Brazeau-area cryoseism M_L 0.4
 756 (Event 7, c & d); scaled spectra have their signals normalized to average unity at 1 Hz. Spectral
 757 plots compare a Brazeau earthquake (crimson coloured lines), Brazeau cryoseism (cool coloured
 758 lines) and the Lac Ste. Anne event (black lines). Regions of low signal to noise ratio are shaded
 759 in grey. Inset seismogram shows vertical velocity waveform data at a nearby station (TD07A).
 760 Additional waveform data can be viewed in Figure S2.

124 Additionally, we qualitatively compare the waveforms and spectra of the Lac Ste. Anne
125 event against a small-magnitude natural event (M_L 0.7) and other small cryoseisms (M_L -0.2 to
126 1.4) in Alberta (Figure S2). This series of seismic events were detected around the Brazeau
127 River and reservoir starting in 2014, and are likely cryoseisms based on their waveform
128 characteristics and timing (Ghofrani & Atkinson, 2018). We note that waveforms from the event

129 on Lac St Anne are more similar to the waveforms of the Brazeau-area cryoseisms (in terms of
130 waveform shape, duration, and frequency content) than to those of the small-sized natural event.
131 These observations become more quantitatively apparent when comparing the displacement
132 spectra of the Lac Ste. Anne event against a Brazeau-area cryoseisms and earthquake (Figure 2).
133 From this figure it can be observed that the Lac St. Anne event has lower power at high
134 frequencies as compared to the small, natural event. Compared with the Brazeau cryoseisms, the
135 event at Lac Ste. Anne is similar in frequency content. It should be noted that the background
136 microseism noise level in the Brazeau area is high at frequencies lower than 1 Hz, causing the
137 pronounced spectral peak at 0.2 Hz.

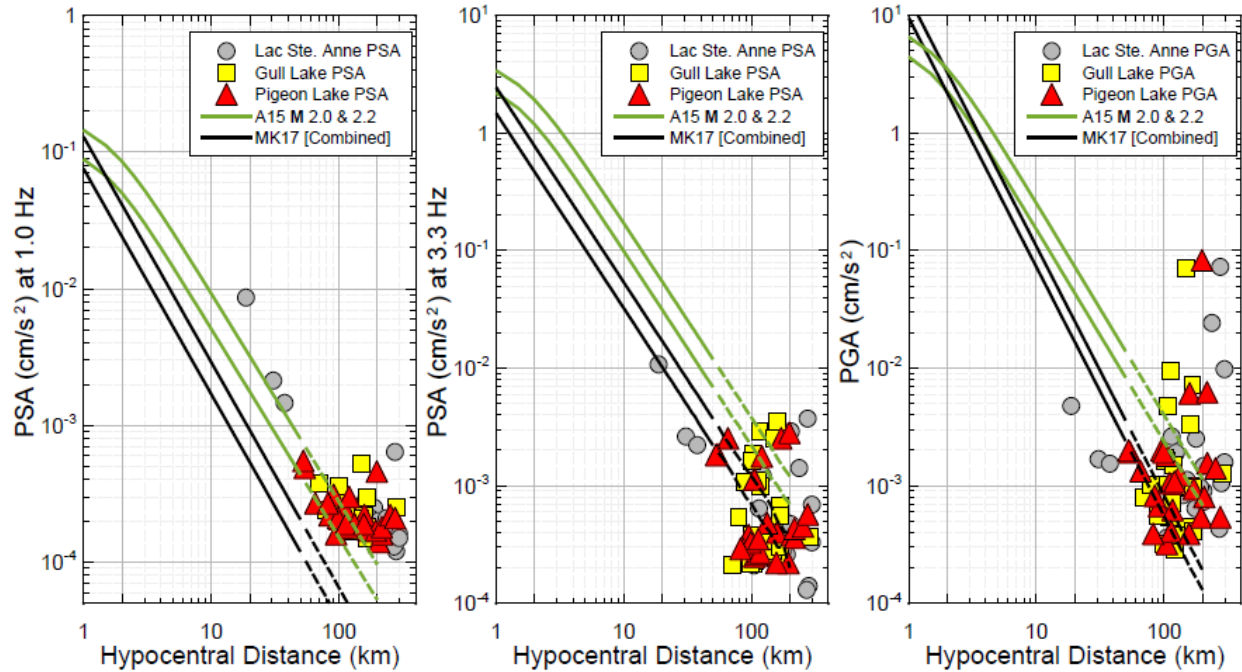
762 **Figure 3. Vertical component ground motions, compared to GMPEs for B/C site condition**
 763 **($V_{s30} = 760$ m/s). Note that the MK17 and A15 models are only for <50 km (shown as dotted**
 764 **lines beyond 50 km). The green and black lines are A15 and MK17 models (for M2.0 and**
 765 **M2.2), respectively.**

115 Small magnitude seismic events were identified at three central Alberta lakes: Lac Ste.
116 Anne, Gull Lake, and Pigeon Lake. To assess the propensity for these events to cause noticeable
117 shaking or potential damage, we compiled a ground motion database of pseudo-spectral
118 acceleration (PSA) from the signals recorded on nearby stations. Briefly, the velocity waveforms
119 are corrected, filtered, and then deconvolved from instrument response (see methods in
120 Assatourians and Atkinson, 2010). Peak ground velocity (PGV) and peak ground acceleration
121 (PGA) values are computed from the maximum amplitudes of processed waveforms. PSAs are
122 calculated from the processed acceleration waveforms following the Nigam and Jennings (1969)
123 formulation for the computation of 5% damped response spectra.

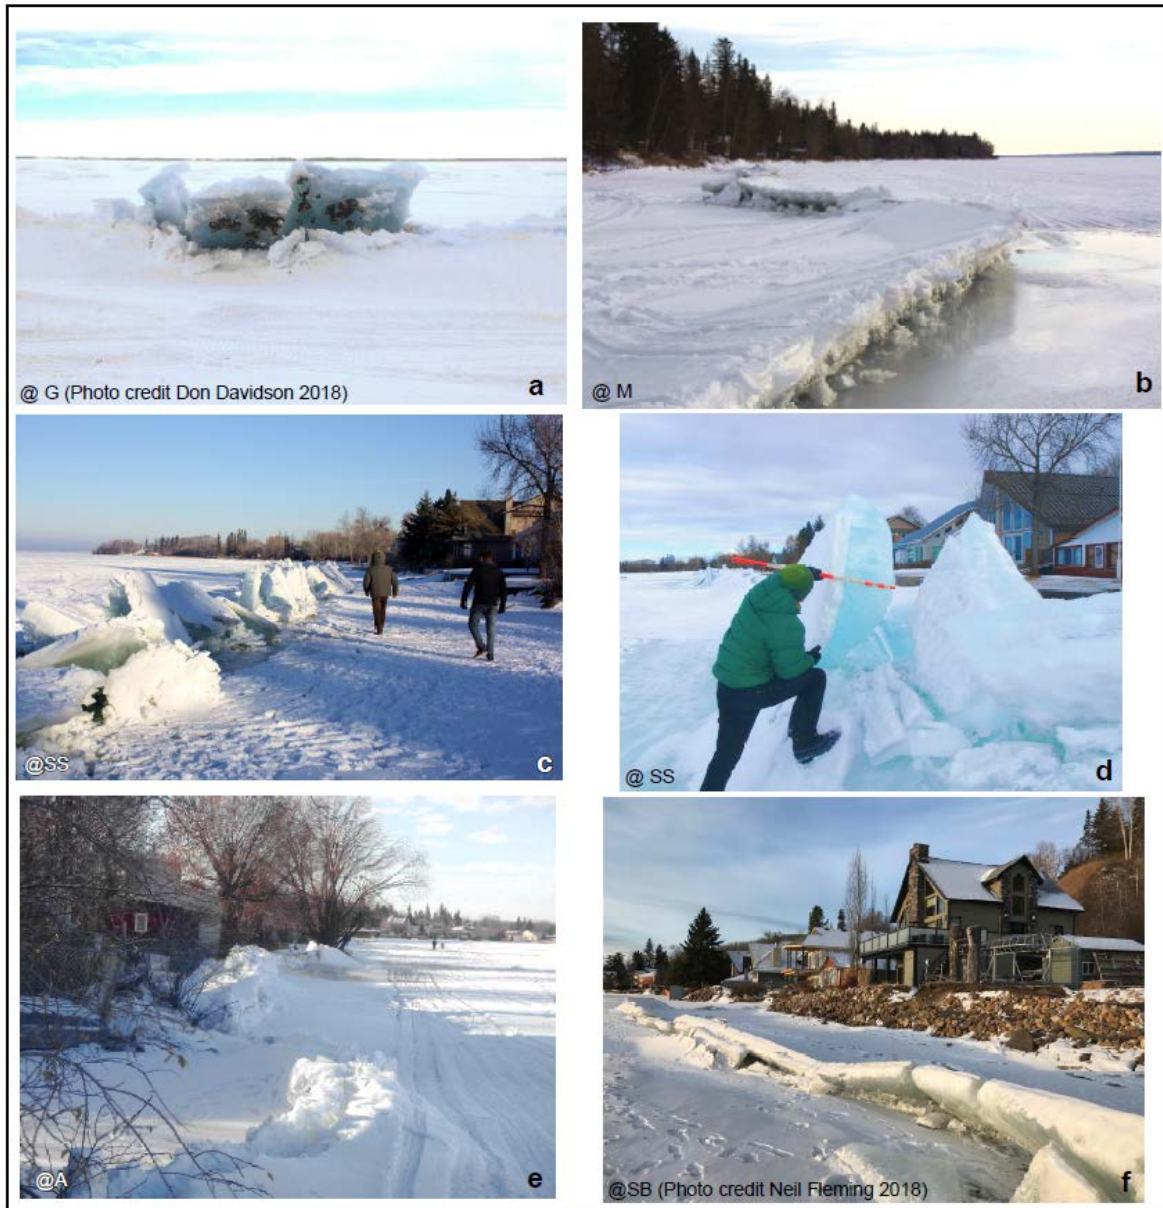
768 **Figure 4. Ice ridges formed on west-central Alberta lakes.** (a) ~1.5m high near-vertical
 769 offshore ice ridge, with embedded lake boulders. Grandview, Pigeon Lake, January 9 2018. (b)
 770 Offshore finger-rafts of over and under-thrust ice slabs, Mulhurst Bay, Pigeon Lake, January 4
 771 2018. (c) ~1.0-1.5 m high, near-vertical, offshore ice ridge, Sunset Beach, Lac. Ste. Anne,
 772 January 5 2018. (d) ~2.0-2.5 m high, near-vertical, offshore ice ridge, Sunset Beach, Lac. Ste.
 773 Anne, January 18 2018. The ice was about 0.35-0.40 m thick at time of rupture on January 1
 774 2018. (e) ~1.5 m high, onshore, ice ridge, Alberta Beach, Lac. Ste. Anne, January 5 2018. (f)
 775 ~1.0 m high, offshore, ice ridge, Seba Beach, Wabamun Lake, January 9 2018. Locations of
 776 pictures are annotated in the bottom left of the panels based on acronyms in Figure 1.

185 Around 23:45 MST January 1, cottage owners at Pigeon Lake (Figure 1d) were alarmed
186 by an explosive sound, with some rushing out of their homes to inspect for damage. The next
187 morning, a view of what happened was apparent: the flat lying lake surface of the previous day
188 had become a 1-2 m high ice ridge extending ~500 m parallel to the shoreline (at about 8-10 m
189 offshore). An AGS visit to Mulhurst Bay (Pigeon Lake) on January 4 observed that slabs of ice
190 were thrust nearly vertically into ice ridges, with as much as 3-4 m of shortening (Figure 4a).
191 Elsewhere, the ice ridge was expressed as finger rafts (Government of Canada Ice Glossary) of
192 alternating over and under thrust slabs of ice (Figure 4b). Inclusions of boulders frozen to the
193 base of some thrust slabs on the opposite side of the lake indicated that ice had frozen to its bed
194 prior to the development of the ice ridge (Figure 4a). No evidence of ground deformation was

497 Given a measured ice thickness $h = 0.4$ m and observed moment magnitude of **M** 2.0,
498 equation 5 requires a rupture length of $L = 383$ m (and a slip distance of $d = 88$ cm). In general,
499 more vertical rupture angles θ will require larger rupture lengths L to produce a similar
500 magnitude event. For example, ice rupture lengths of $L = 1.8$ km would be required to produce a
501 **M** 2.0 event with subvertical ice shearing. Overall, these results are consistent with overnight
502 pressure/ice ridge and ice folding at Pigeon Lake and Lac Ste. Anne. For example, numerous
503 sets of pressure/ice ridges were observed on both lakes, extending for hundreds of metres with
504 metres (3-4 m) of displaced ice following the first warming period (Figures 4 & 12). At Pigeon
505 Lake, one such pressure/ice ridge on the eastern portion of the lake displayed clear evidence of
506 periodic under/over-thrusting behavior (Figure 4b).

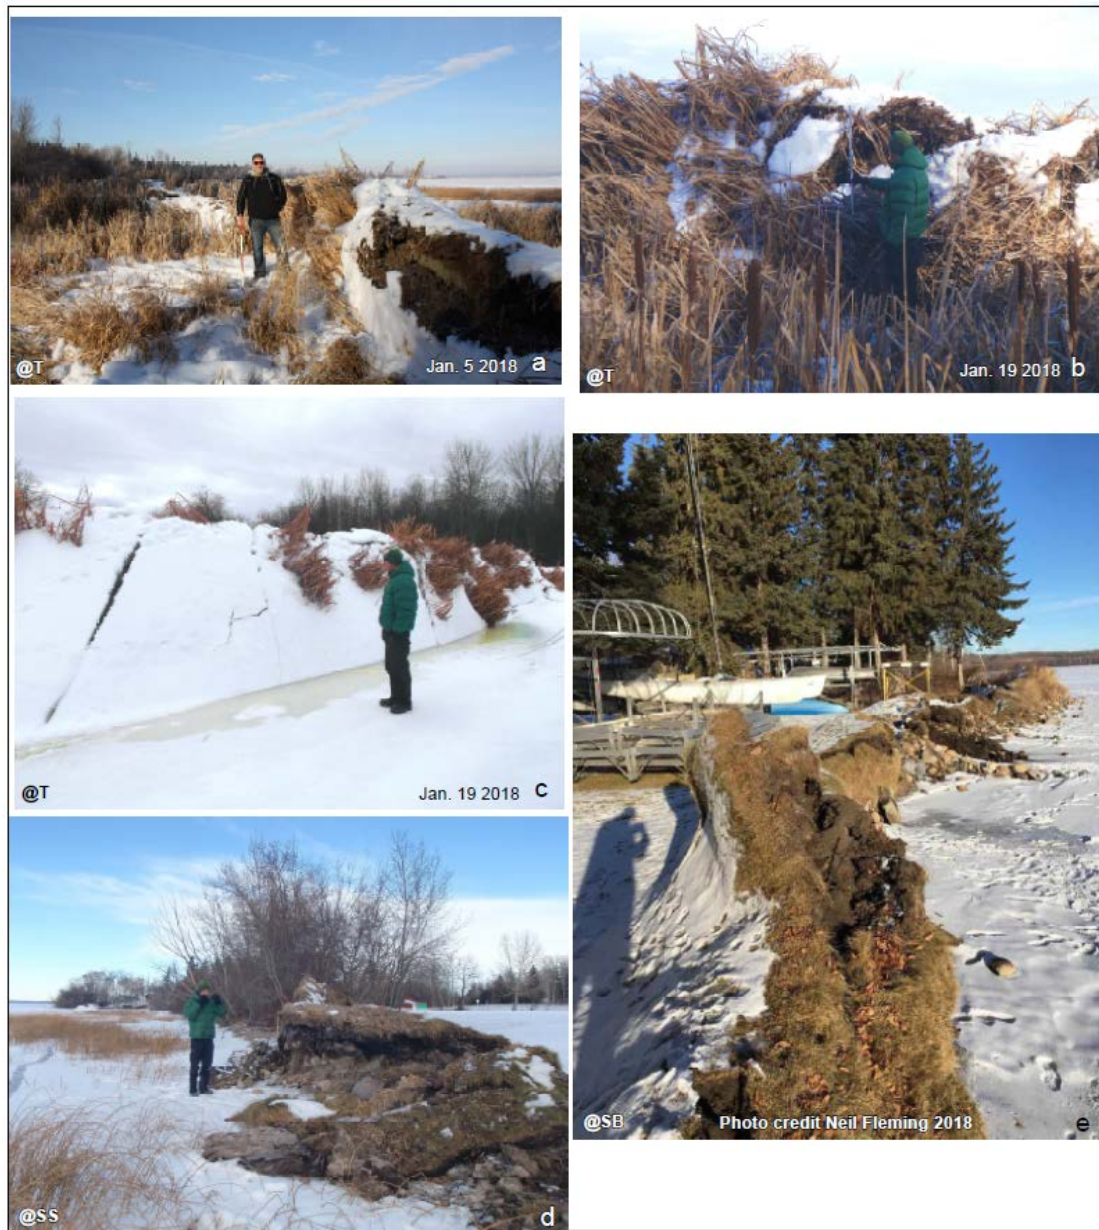
779 **Figure 5. Deformed shorelines.** (a) 1.0-1.5 m high, thrusted and folded marshy shoreline at the
 780 Thibeault site, Lac Ste. Anne on January 5 2018. (b & c) Same location, but taken two weeks
 781 after photo (a); the height of thrust increased by at least 1 m. (c) Lake-side view of photo (b),
 782 with ~2.5m high near-vertical thrust ridge of frozen marshy ground. Lake ice plunges beneath
 783 thrust ridge, and water rises to surface. (d) Thrusted, folded shoreline at Sunset Beach, Lac. Ste.
 784 Anne, January 19 2018. Note re-frozen lead (crack) on flat lake ice at the left edge of the photo.
 785 (e) Thrusted, folded shoreline and undeformed lake ice adjacent to thrust ridge at Seba Beach,
 786 Wabamun Lake, January 7-9 2018. In all photos, note the sparse snow cover. Locations of
 787 photos are annotated in the bottom left of the panels based on acronyms in Figure 1.

219 By far the biggest impact of the icequake event was the deformation and/or displacement
220 of frozen ground along the shorelines of Lac Ste. Anne and Wabamun Lake. Deformation
221 occurred in the form of thrust, folded and overturned folded slabs of frozen ground, about 0.4
222 m thick, extending along shorelines for segmented distances of kilometres (Figure 5). These
223 deformations were observed at many locations around Lac Ste. Anne, and along much of the
224 west and north shoreline of Wabamun Lake. At Lac Ste. Anne, thrust slabs were observed to
225 grow in height from initially about 1 m (January 5 2018) to as much as 2.5 m in the weeks
226 following the seismic event (Figure 5 a,b,c). Conspicuously evident was the inverse relationship
227 between the occurrence of offshore ice ridges and onshore ground deformation; in almost all
228 cases where significant ground deformation occurred (with the exception of ice-ramping at

229 Alberta Beach) lake ice was undeformed up to the shoreline; no evidence of ice ridge
230 development was apparent (Figure 5 d,e) other than subtle downward warping beneath the
231 displaced thrust sheets (Figure 5c). Conversely, ground deformation was not observed in those
232 areas where ice ridges developed offshore. Associated with flat, undeformed lake ice were a
233 number of offshore ice leads, some showing multiple opening and refreezing cycles. The
234 significance of these to the creation of ground deformation and displacement is discussed later.

294 GPR transect 2 terminated within a metre of the shoreline, where flat, undeformed lake
295 ice abutted to thrust and folded ground. A lake-depth sounding taken within less than a metre
296 of the shoreline showed that ice was floating on at least 0.1 m of free water. Multiple refrozen
297 ice cracks, or leads, were also conspicuous tens of metres away from, but parallel to, the
298 shoreline (Figure 5d).

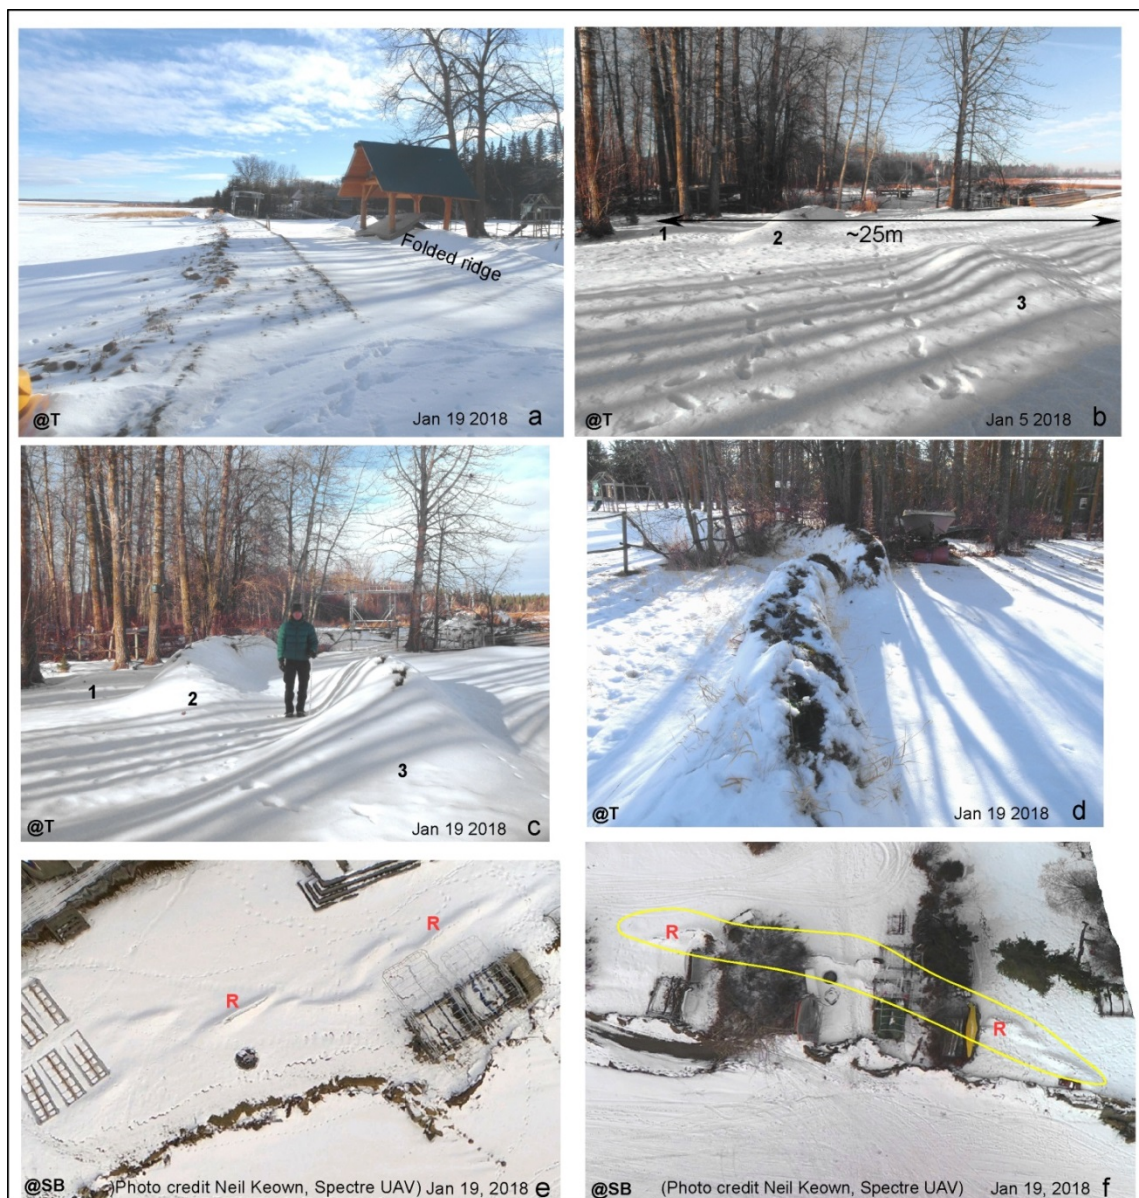
789
 790 **Figure 6. Inland ground deformations.** (a) View of undeformed lake ice in contact with shore,
 791 and folded, deformed ground onshore beneath the gazebo structure at the Thibeault site, Lac. Ste.
 792 Anne, January 19 2018. (b) Multiple inland ground folds (numbered) at the Thibeault site, Lac.
 793 Ste. Anne, January 5 2018. Photo (b) taken 5 days after the icequake, during which time folds
 794 grew to about 0.5 m in height. (c & d) Photos taken two weeks later, during which time folds
 795 have doubled in height and ruptured. (e & f) Aerial view (UAV imagery) of folded ground at
 796 two sites near Seba Beach, Wabamun Lake. Ridges in photo (e) are about 0.3-0.4 m high and 7-
 797 13 m long. Ruptures (R) are evident in some of the folds. (f) Ridges in photo (highlighted in
 798 yellow) are about 0.4-0.5 m high and 5-8 m long. Locations of pictures are annotated in the
 799 bottom left of the panels based on acronyms in Figure 1.

235 Of particular note was the occurrence of ground deformation in the form of multiple
236 folds, rather than thrusts (Figure 6). Folds at the Thibeault site at Lac Ste. Anne occurred in flat
237 terrain situated on the margins of a wetland where sediments were highly saturated prior to
238 freeze-up (based on comments by the landowners in the area). Ground folds at Thibeault were
239 observed as much as 25 m inland from the shoreline, and grew to a height of about 0.5 m during
240 the 24 hours following the seismic event on January 1, (Figure 6b). By January 19 (2.5 weeks

241 later) the height of these folds grew an additional metre, causing most to rupture along their fold
242 axis (Figure 6 c,d). Similar inland folded terrain was observed from UAV imagery at a number
243 of locations along Seba Beach on the western end of Wabamun Lake. Based on cracks visible in
244 the snow cover, some folds appear to have ruptured shortly after their formation (Figure 6 e,f).

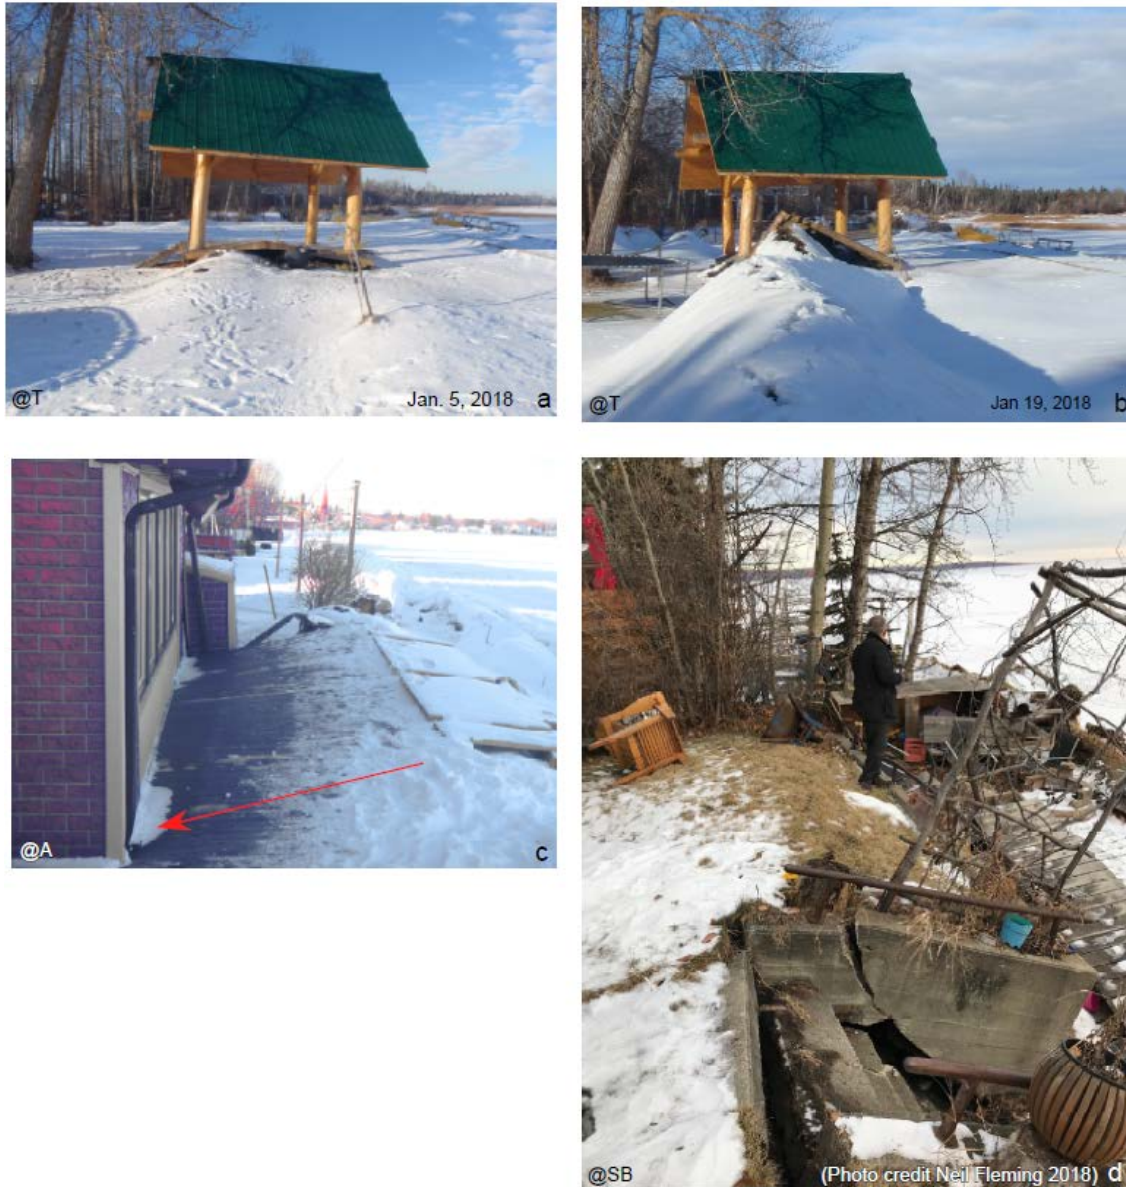
803 **Figure 7. Damage to infrastructure following the icequakes.** (a & b) Damaged decking and
 804 pillar footings of gazebo structure situated above deformed, folded ground ridge, Thibeault, Lac
 805 Ste. Anne. Further damage to structure occurred as folds grew in height over a two-week period
 806 (b). Multiple folds are visible in background in left edge of photo (b). (c) Deck deformed and
 807 displaced by onshore ice ridge, Lac Ste. Anne. (d) Sheared concrete retaining wall, Seba Beach
 808 area, Wabamun Lake. Locations of pictures are annotated in the bottom left of the panels based
 809 on acronyms in Figure 1.

246 The greatest issue property owners faced at Lac. Ste. Anne and Wabamun Lake (e.g.,
247 Wabamun Watershed Management Council Website, 2018; Don Meredith Outdoors Blog, 2018)
248 was the widespread damage to buildings and other shoreline infrastructure that occurred
249 following the seismic event (Figures 7 & S3). Initial damage to infrastructure took many forms,
250 some of which could be related directly to ice or ground deformation. For example, upheaval of
251 external building structures occurred beneath the Thibeault thrust folds (Figure 7 a,b) and
252 damage to landscaping and other structures along shore were evident at Sunset Beach at Lac. Ste.
253 Anne and Seba Beach at Wabamun Lake (Figure 7d). Ramping of an ice ridge onto shore at
254 Alberta Beach caused deformation of decking and dislocation of buildings from their foundations
255 (Figure 7c). However, in the Val Quentin area, horizontal dislocation of decking/buildings from

256 their foundations (Figures S3 a,b) and compression/crushing of concrete foundations occurred in
257 areas where expressions of either ice ridges, or significant ground deformation were not visible
258 (Figure S3 c). These forms of structural damage occurred inland from the shoreline, much in the
259 same manner that ground folds developed inland from the shoreline at Thibeault and Seba Beach
260 (Figures 5 & 6). Damage to infrastructure was not confined to just the brief period following the
261 seismic event, however. There was sustained damage that occurred in the few weeks following
262 the initial event, as ground folds continued to grow (Figure 7 a,b).

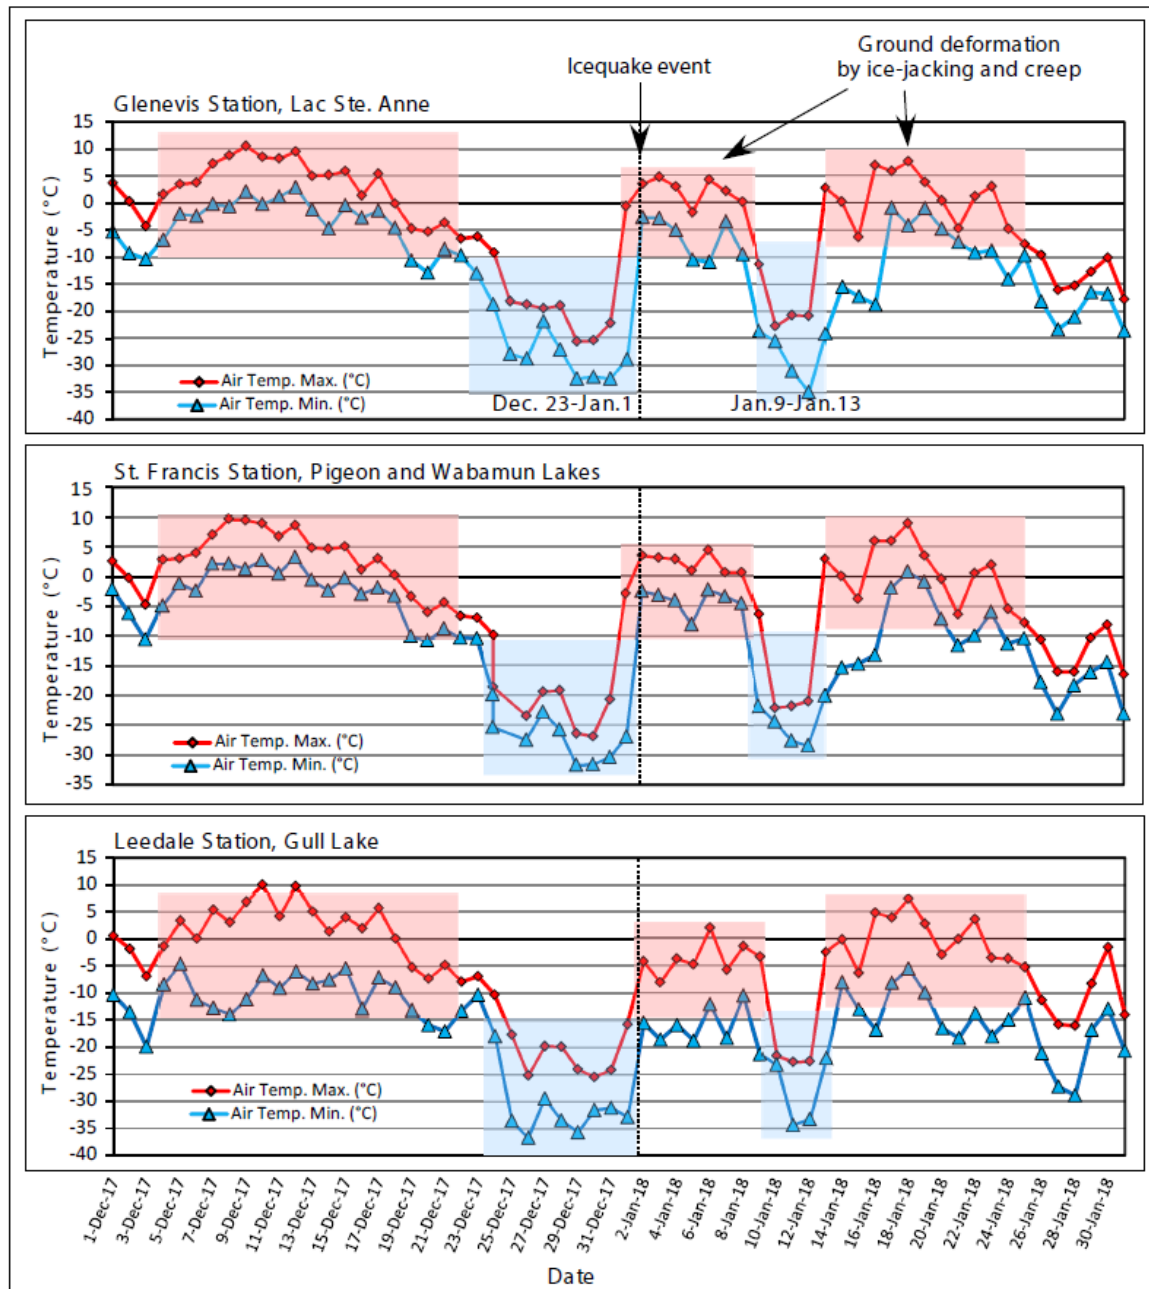
821
 822 **Figure 9. Daily minimum (blue line) and maximum (red line) temperatures in the weeks**
 823 **preceding the icequake event, at the weather stations near relevant lakes.** Prolonged cold
 824 periods (Blue-shaded areas) around -30°C preceded the seismic event (dashed line) between
 825 December 23 and January 1. Red-shaded areas highlight periods of near or above freezing
 826 temperatures. Two cycles of rapid temperature drop followed by rapid warming are recorded in
 827 the latter part of December 2017 and mid-January 2018.

340 Following the seismic events of January 1, a second abrupt warming was observed on
341 January 13 2018. As in the case for the January 1 warming, the January 13 warming was
342 preceded by a ~3-day long period of intense cold (Figure 9), with temperatures ranging between
343 -34.9°C and -20.6°C and averaging -26.2°C . Beginning at 22:00 MST on January 12,
344 temperatures warmed from -27.2°C to $+2.8^{\circ}\text{C}$ (a change of $+30.0^{\circ}\text{C}$) over a 16 hour period.
345 During this warming interval, hourly averaged wind speeds increased from near still conditions
346 to approximately 20 km/hr while veering from South to West (Figure S5).

357 Abnormal meteorological and hydrological conditions occurred prior to the seismic event
 358 on January 1. Firstly, there was a sustained period of extreme cold and rapid freezing of both
 359 lake ice and ground surface (Figure 9 & S6). This was followed by a rapid warming period,
 360 which saw the daily minimum and maximum air temperatures increase by as much 25-30°C
 361 within a 24 hour period (Figure 9). While temperature swings of this magnitude are not
 362 uncommon, the coupling of this observation with cool and arid conditions is rare: similar low 7-
 363 day average temperatures are observed once every 6-12 years (Figure S6), and similar snow
 364 precipitation preceding the seismic events (Figure 10) were either low (Lac Ste. Anne; once in 6-
 365 12 years) or moderately low (Pigeon and Gull lakes; once in 3-6 years). Thus, this rapid change
 366 in atmospheric temperature was expressed directly to ice due to the near-absence of an insulating

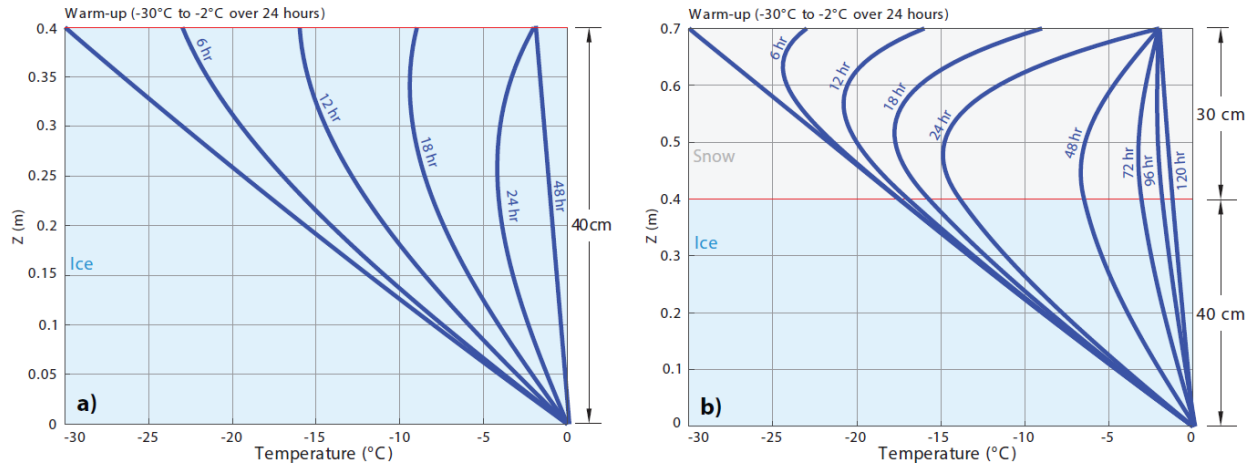
838 **Figure 11. Effects of snow cover on the thermal conductivity of air temperature into ice.** (a)
 839 Modelled temperature profiles (blue curves) for the warming scenario with a 40 cm thick layer of
 840 lake ice (blue area). (b) Modelled temperature profiles (blue curves) for the scenario with a 30
 841 cm thick snowpack (grey area) overlying lake ice (blue area).

413 Modelled temperature profiles from the snow-free and snow-covered scenarios are shown
414 in Figure 11. Comparison of these two figures shows that ice temperature changes during the 24
415 hours of warming are strongly influenced by the absence or presence of snow cover. For the case
416 with no snow, the ice surface warms by the full 27°C (as prescribed at the model's upper
417 boundary condition), while the depth-averaged ice temperature increases by 12.5°C . In contrast,
418 for the case with a 0.3 m thick snow cover, the temperature increase largely occurs within the
419 layer of snow, and as a result the upper ice surface warms by just 3.5°C and the depth-averaged
420 ice temperature by only 1.4°C .

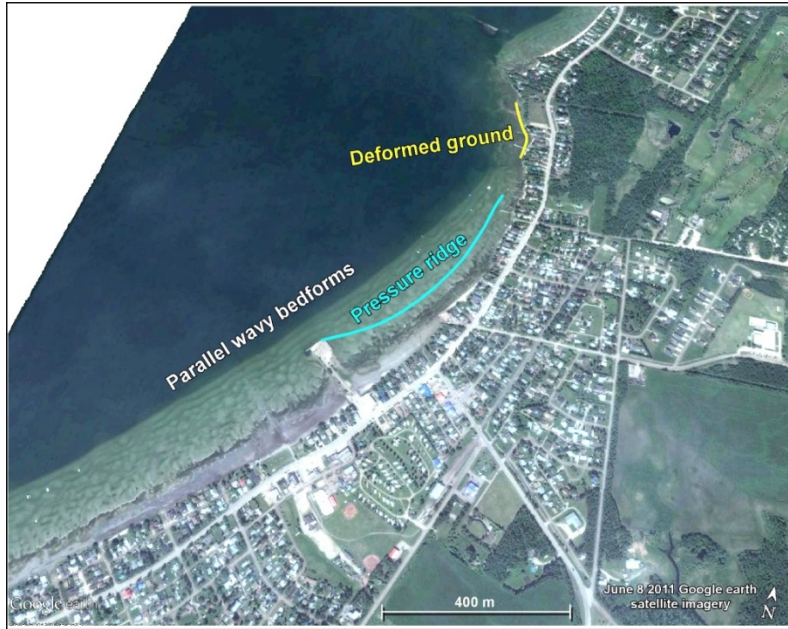
844 **Figure 12. Lake-bottom bedforms, approximate positions of pressure/ice ridge, and ground**
 845 **deformation along Sunset Beach, Lac. Ste. Anne.** Pressure/ice ridges have developed in areas
 846 with shallow shorelines (depicted as longitudinal, parallel to sub-parallel sandy depositional
 847 bedforms beneath shallow water in 2011 Google Earth imagery) where lake ice had frozen to its
 848 bed. In areas with steeper shorelines, expanding lake ice floated on water, likely transferring
 849 more stress and causing more damage to the shoreline.
